DEFORMATION IN MULTILAYER FIBERGLASS BEAMS AT DIFFERENT POSITIONS OF CONCENTRATED LOAD

Abstract: We analyzed the load and deformation in hollow beams made from multilayered glass-fiber-reinforced polymer, specifically assessing deformation under concentrated load. We performed nonlinear numerical analysis on beam with rectangular cross-sections with set dimensions and material properties. Beams with three different spans were analyzed, loaded with two concentrated forces at varying distances between applied force and supports. As the force was increased, we assessed the deformation near the supports. These results are shown in dimensionless diagrams, where the ratio of the applied and initial force correlates to the ratio of deformation near the support to deformation near the mid-span.

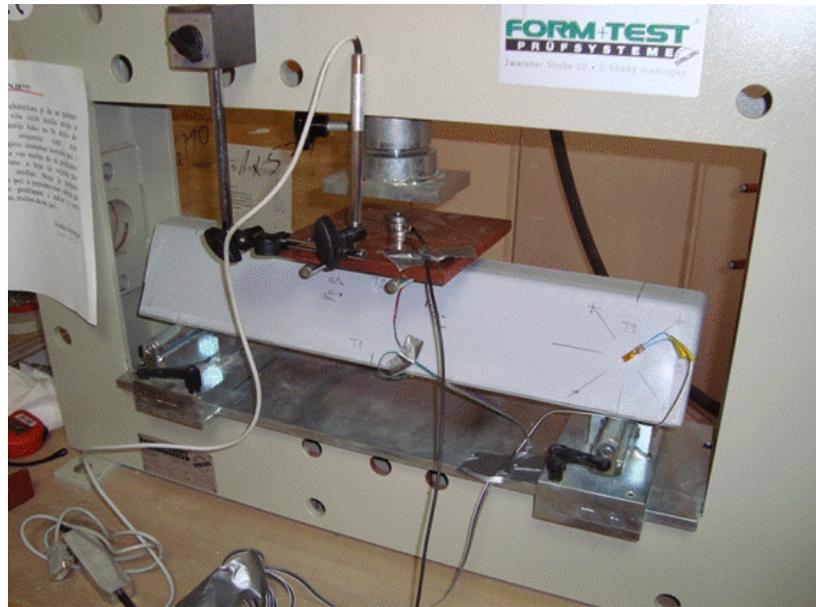
Also, in our previous work [2], the glass-fiber-reinforced polymer beams were tested using four-point bending (4PB), as shown in Fig. 3.

Figure 3. Test rig for fiber-reinforced polymer beams

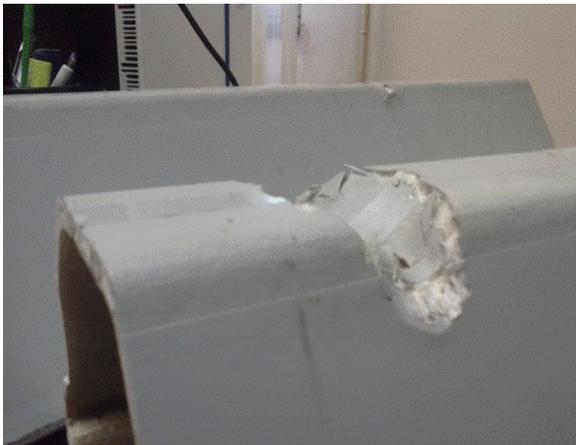
While analyzing the behavior of these beams, we found that significant stress concentration near the applied concentrated forces caused deformation of the beam, as shown in Fig. 4. Deformation occurred both at the site of applied load and at the supports. These results show that this combination of loading and supports is unfavorable for this material, cross-section, and beam.

Figure 4. Photograph of beam deformation
