## STUDENČICA BRIDGE TESTING

**Abstract:** Studenčica bridge is located at Donji Studenci, to the southwest of Mostar in Bosnia and Herzegovina. The bridge is a great feat of engineering. It is built at a height of 88 m above the valley and is 555 m long, with main spans of 120 m. Before the bridge was opened for traffic, it was subjected to a series of tests to verify whether the construction satisfied the criteria regulated by law. Static and dynamic tests were conducted to confirm the safety of the bridge. Before the tests commenced, a numerical model of the bridge was developed and calculated by using a computer program (TOWER), and the calculation results were later compared with the measured values. The static tests comprised measurement of vertical deformation and stress in the construction, and the dynamic test involved measurement of the oscillation frequencies of the bridge. The results were analyzed to check whether the bridge performs as expected and whether it can be opened for traffic.

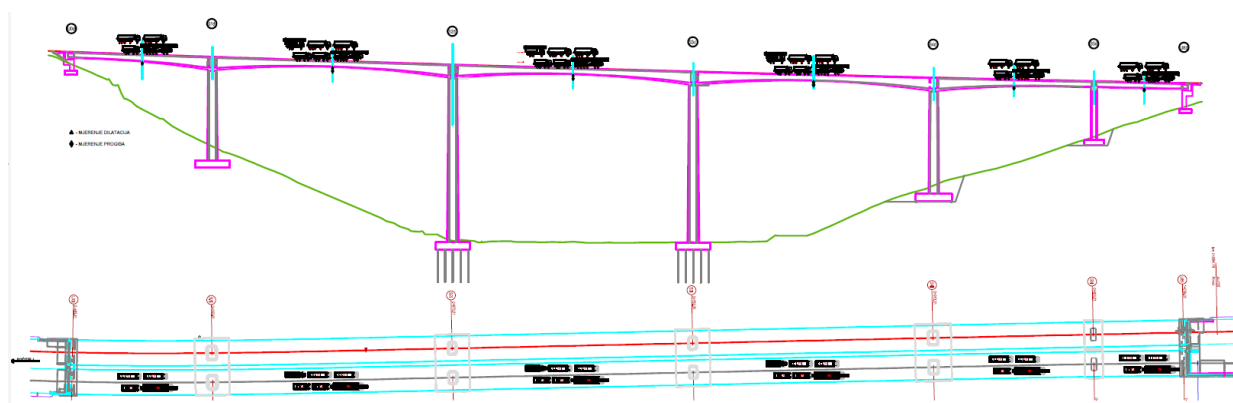
Figure 2 Illustration of span testing [6]

Static tests of the bridge are conducted by applying load on bridge spans and above piers to cause deformations and stresses in the construction. In the present case, the load was six trucks weighing 30–50 tons. The weight of the trucks was distributed on their axles and was used as such in the calculation. Appropriate positioning of the trucks on the bridge (Figures 2, 3 and 4) resulted in the desired stress and deformation in the construction, and different positions were used to test the three spans and two piers. The test load was 56% of the live load (coefficient  $U = 0.56$ ).

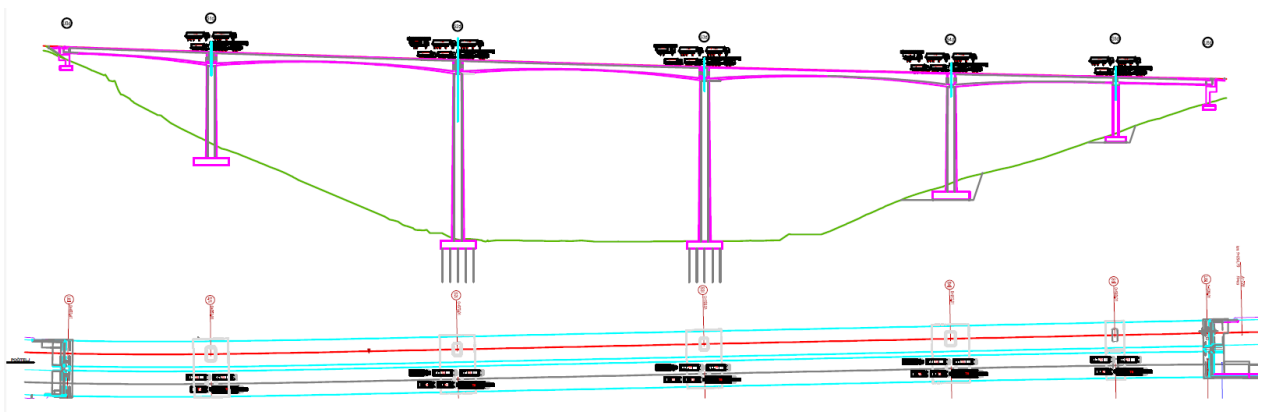
Figure 3 Illustration of pier testing [6]
